Asian Journal of Environmental Studies (AJES)

Earthquake-Proof Building Materials for Earthquake-Prone Areas

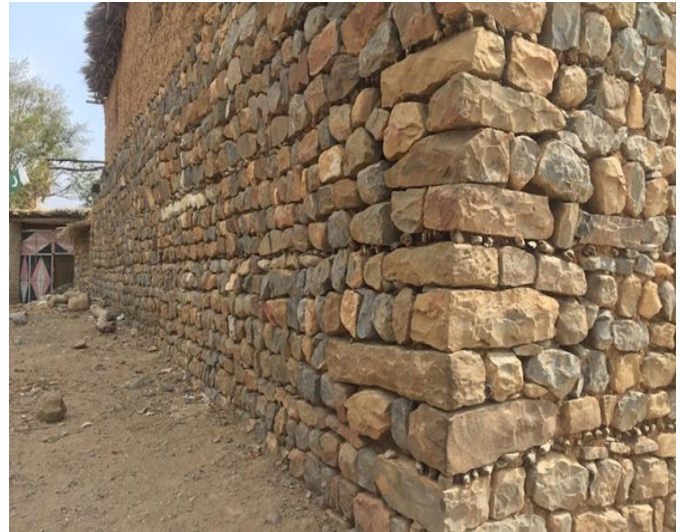
Post-earthquake studies show that houses with thick stone or mud walls of about 600 to 1000 mm and roofs with a 150 to 450 mm thick layer of clay prove most dangerous in an earthquake. It showed that the greater the weight of the building is, the more dangerous it is thus, the damage to the structure is a function of its weight. In rural areas, the walls are generally made of mud mixed with dry grass or wheat husk, clay bricks, and stones. The roofs are supported by strong wood bars to overcome the effect of an earthquake. Mud is placed between clay bricks or stones to make its grip strong, and no blank spaces are left between them (Schildkamp et al., 2021).

Figure 2 Stone buildings commonly used in rural areas.

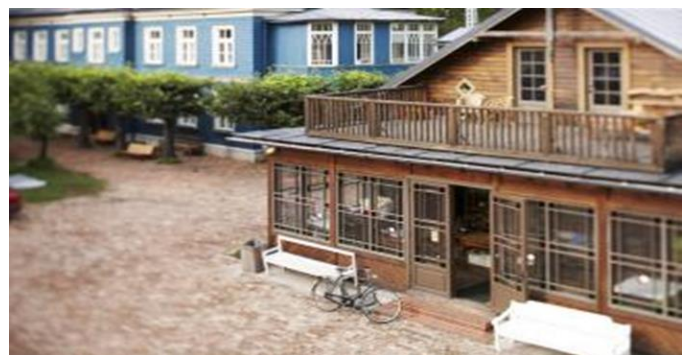
Houses made of wood are tied together with roofs made up of dried plant materials that are lighter such as rice or wheat straws and thatch, supported by a wooden beam. The houses with or without mud plaster were found to be resistant to earthquakes due to their lightweight weight and beam support. Similarly, flat roofs with wooden frames in which roof components are connected with vertical and horizontal beams, are found to be safe during earthquakes. The roof supported by wooden beams prevents inward collapse of the walls resulting safety of natives (Inoue et al., 2023).

Figure 3 Wooden house

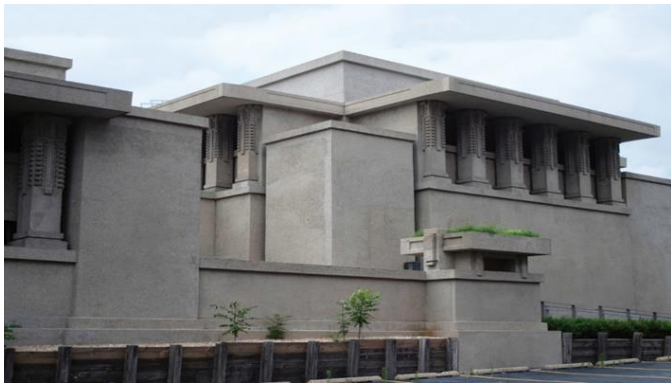
In urban areas, the people are high class, and they cannot live in houses made of clay, wood, or stones because it is costly and not easily available. So, buildings with concrete, baked bricks, and cement are made with round and flat steel rods fitted in with concrete roofs. The weight of the roof and walls is kept less as buildings with high weight are dangerous in an earthquake. Maximum beams are given between the walls and the length of the

walls is kept short to withstand the earthquake. If the wall is lengthy, the two walls are connected beams with iron rods that hold it tight. Also, square-type buildings are preferred safe as compared to rectangular buildings because it reduces their length and makes them strong (Guri et al., 2022).

Figure 4 Concrete buildings commonly used in urban areas.

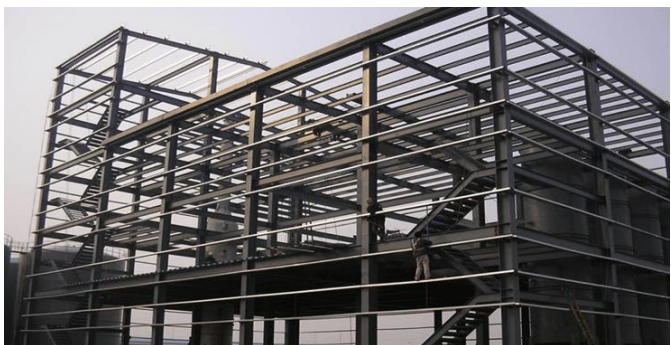
A skeleton system is applied on walls which consists of a steel truss. The walls and roofs are supported by steel columns by holding down the bolts fitted in reinforced cement concrete (RCC) or burnt brick roofs. All the parts of the materials are connected with nuts and bolts to make a single unit. Corrugated Galvanized Iron (CGI) sheets are used in roof coverings which are non-corrosive and strong materials to prevent the buildings from earthquakes. The wind bracings are used on both opposite sides of walls longitudinally to make them strong, rigid, and safe against winds and are also easy to handle (Chen & Qian, 2023).

Figure 5 Plates welded to steel bars in skeleton system.

The skeleton system is also advantageous as it can be completed in multiple stages depending upon the financial resources. Once this system is adopted, it may be used for primary requirements and then for further construction like flooring and joinery, etc.
